Understanding the Z-Curve

USBM Z-CURVE (USBM RI 8507)
Threshold damage vibration criteria

Permanent Monitoring Units

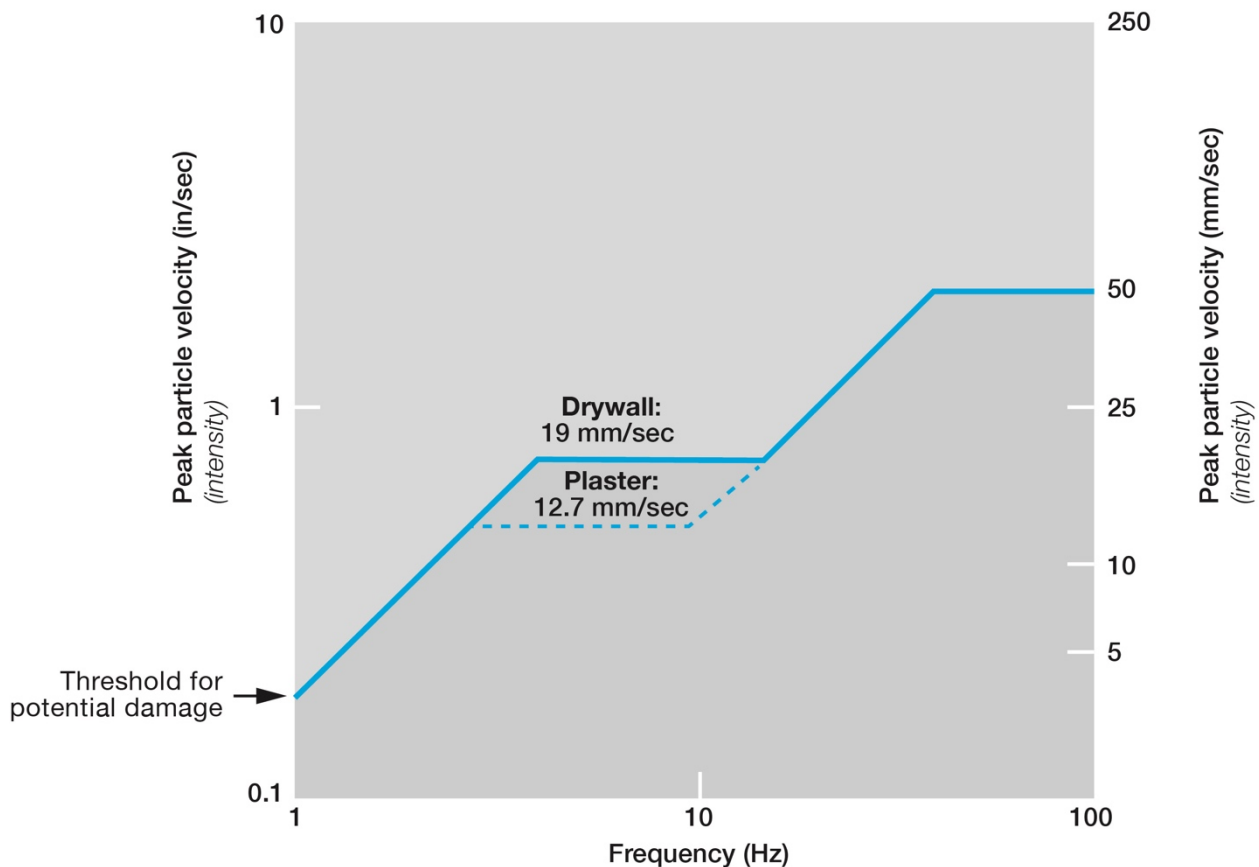
The Z-Curve line establishes a limit above which damage becomes possible, but it is crucial to note that damage does not automatically occur once this limit is breached. Damage would not actually occur in the average residence until ground vibrations reached significantly higher intensities than those outlined by the USBM Z-Curve. If the Z-Curve criteria is exceeded, the probability of damage is merely introduced and will incrementally increase with higher and higher vibration amplitudes.

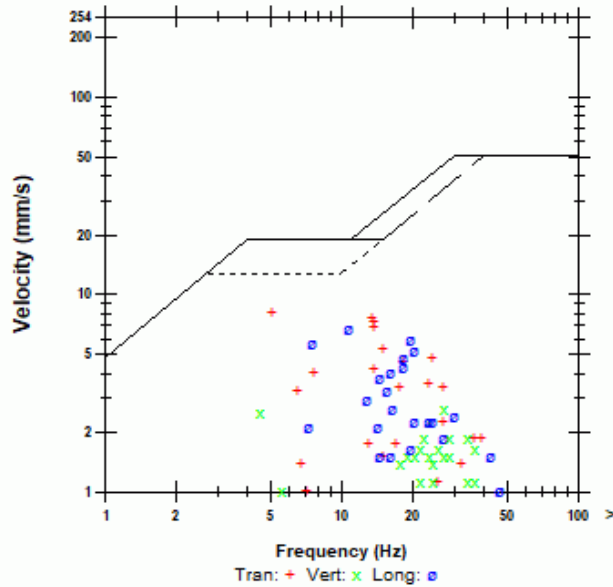
USBM R18507 And OSMRE

Tran	Vert	Long	
PPV	8.13	2.67	6.73	mm/s
ZC Freq	5.1	27	11	Hz
Time (Rel. to Trig)	0.349	-0.028	0.304	sec
Peak Acceleration	0.106	0.0530	0.0663	g
Peak Displacement	0.140	0.0701	0.0982	mm
Sensor Check	Disabled	Disabled	Disabled

Peak Vector Sum 9.47 mm/s At 0.313 sec.

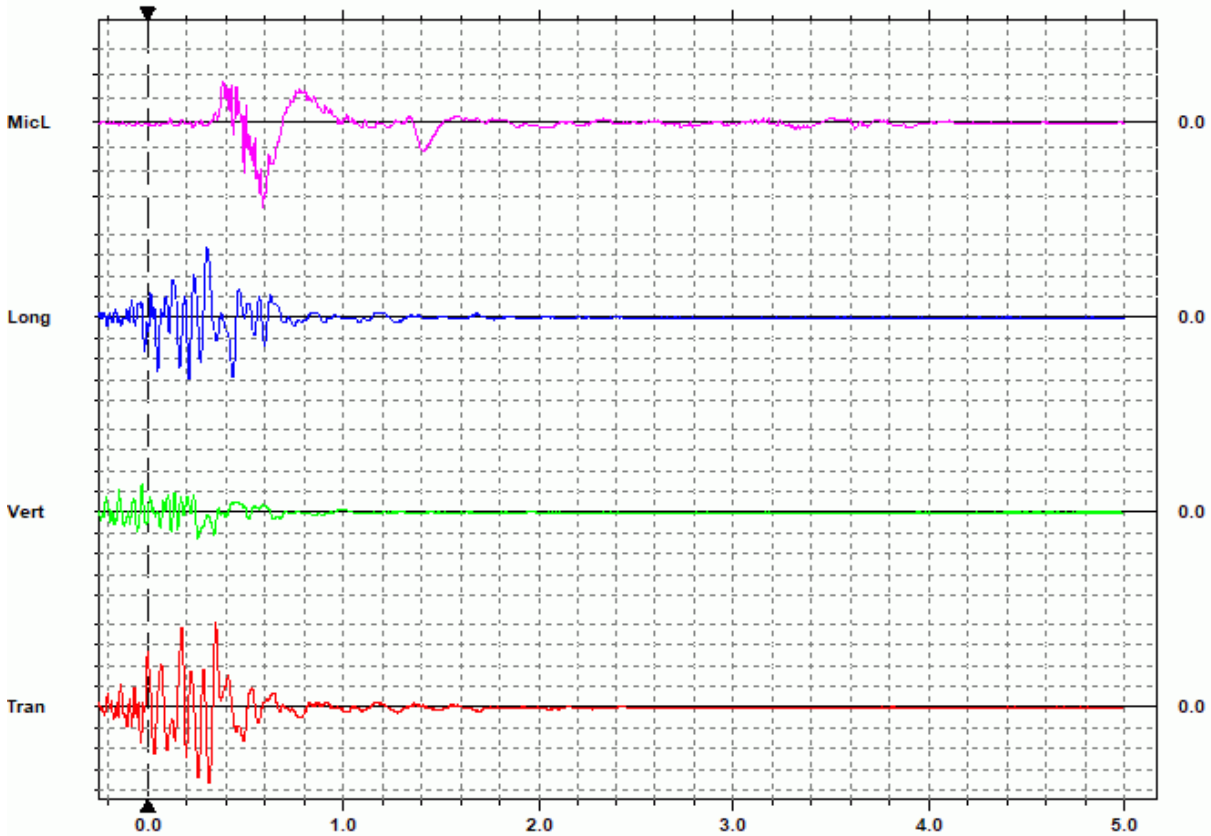
Combo Mode August 18, 2020 05:17:10
 Geophone is sandbagged under the stairs of the backyard deck at 97 Cougar Ridge Close SW adjacent ongoing blasting operations.

Time(Seconds) 0.20 sec/div Amplitude Geo: 2.00 mm/s/div Mic: 10.00 pa.(L)/div
 Trigger =

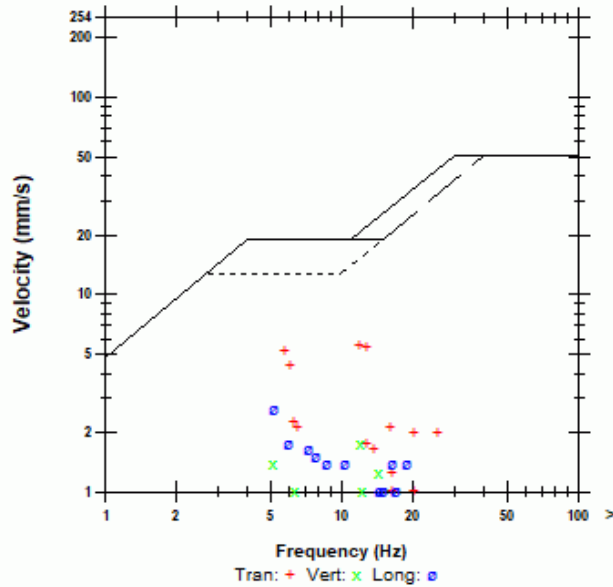
USBM R18507 And OSMRE

Tran	Vert	Long	
PPV	5.59	1.78	2.67	mm/s
ZC Freq	12	12	5.2	Hz
Time (Rel. to Trig)	0.005	0.004	0.178	sec
Peak Acceleration	0.0530	0.0398	0.0398	g
Peak Displacement	0.118	0.0454	0.0796	mm
Sensor Check	Disabled	Disabled	Disabled

Peak Vector Sum 6.03 mm/s At 0.005 sec.

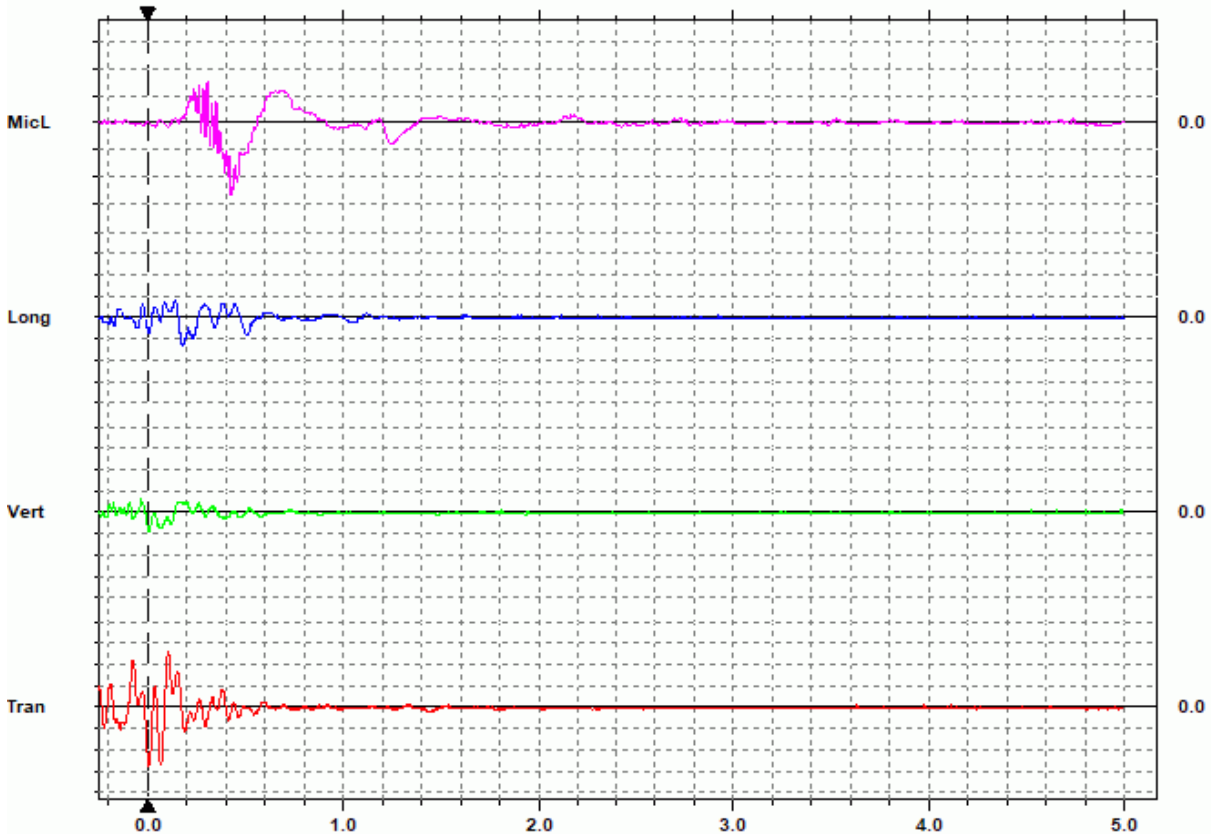
Combo Mode August 18, 2020 05:16:47
 Geophone is sandbagged along the Western wall in the backyard of 77 Cougar Ridge Close SW adjacent ongoing blasting operations.

Time(Seconds) 0.20 sec/div Amplitude Geo: 2.00 mm/s/div Mic: 10.00 pa.(L)/div
 Trigger =

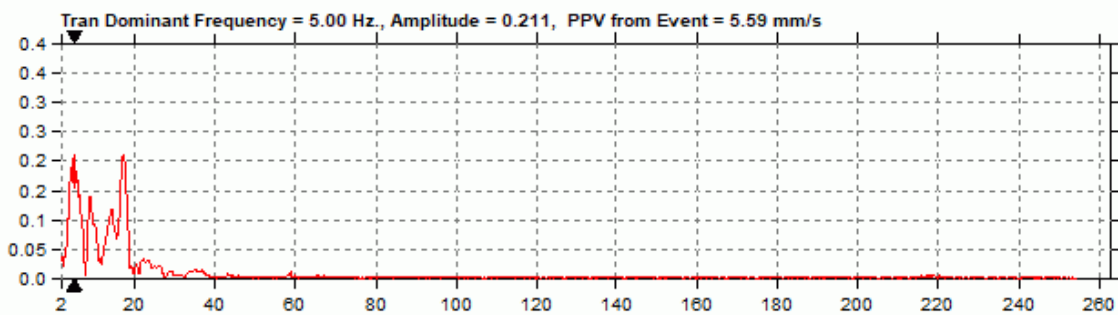
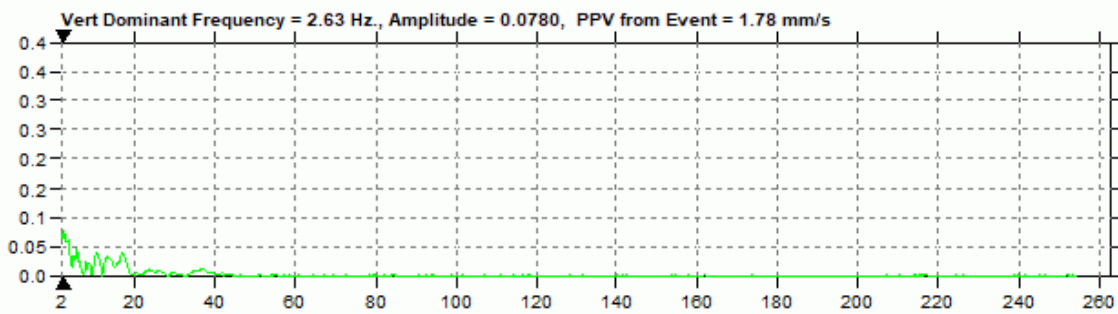
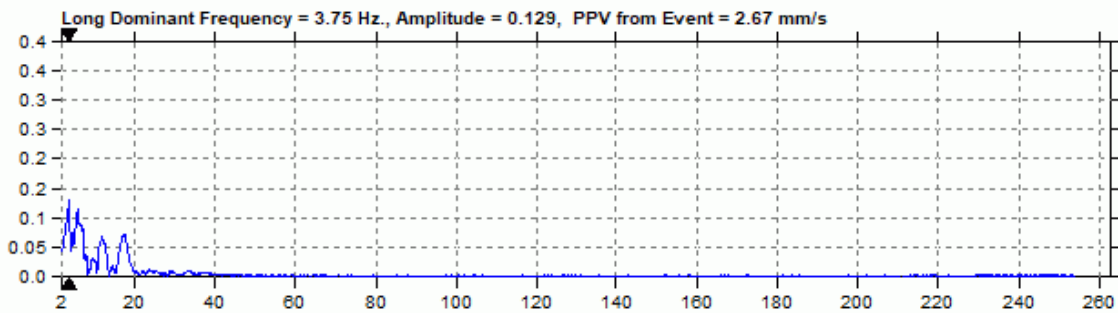
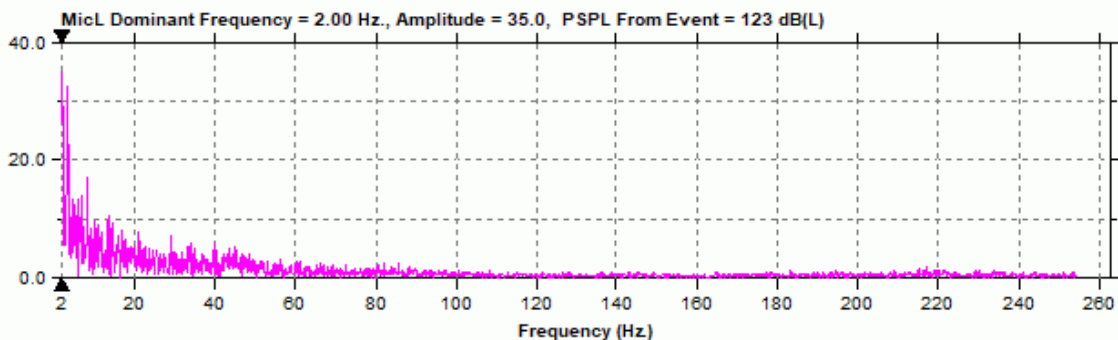
Combo Mode August 18, 2020 05:16:47
Geophone is sandbagged along the Western wall in the backyard of 77 Cougar Ridge Close SW adjacent ongoing blasting operations.
